Manhole Inspection Summary

Manhole # S49C__013MH

Insp Date: **6/11/08 12:51 PM**

Location Address: **200 n glover st**

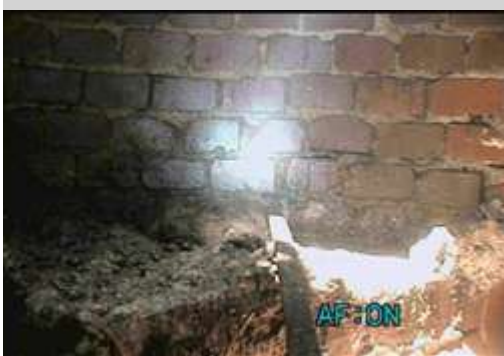
Defect 3

Condition: ☐ Sound ☐ Cracked ☐ Root Intrusion ☐ Deteriorated ☐ Leaks ☒ **Debris**

bench debris

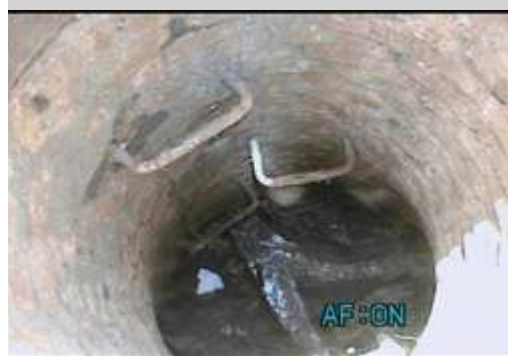
Defect 2

Count: **4** Missing: **0** ☒ **Corroded**

corroded steps

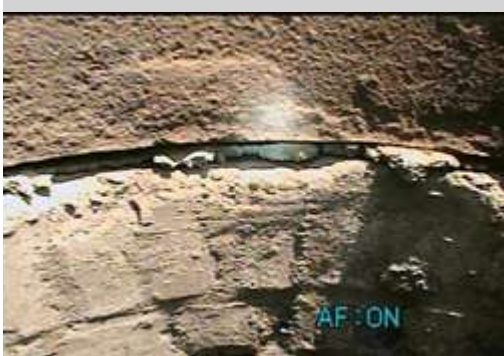
Defect 1

Condition: ☐ Sound ☐ Cracked ☐ Root Intrusion ☐ Loose Brick ☒ **Deteriorated**

Infiltration: ☐ None ☒ **Joint** ☐ Cracks ☐ Mortar ☐ Roots ☐ Wall

chimney loose bricks, signs of infiltration at joint, frame adj
